Hudsonotes

Column of Mechanical Miscellany
by George Schmidt
Mishicot, Wisc.

Door and Body Repairs

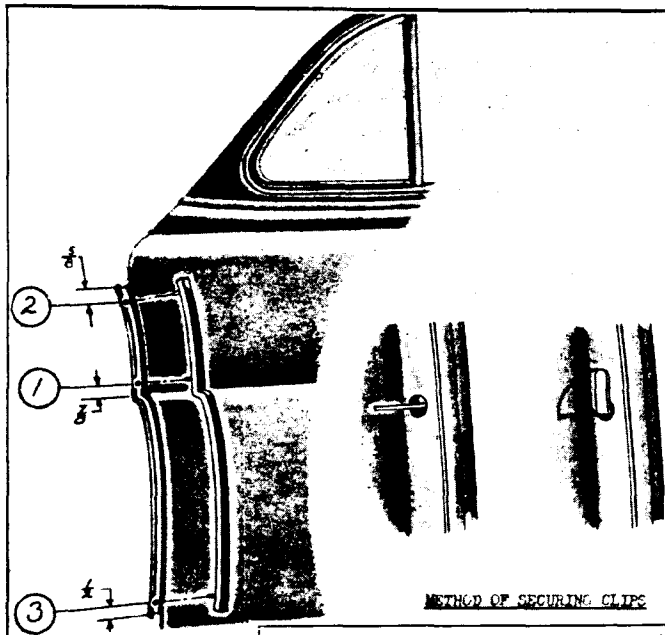
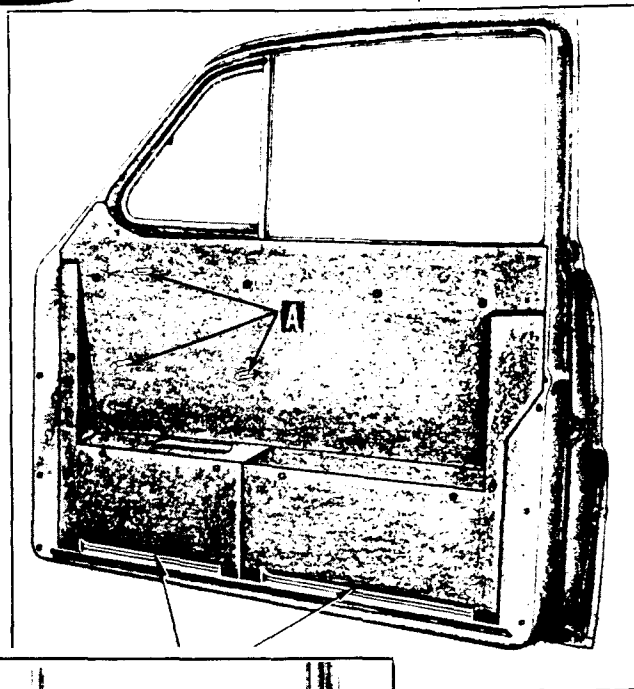
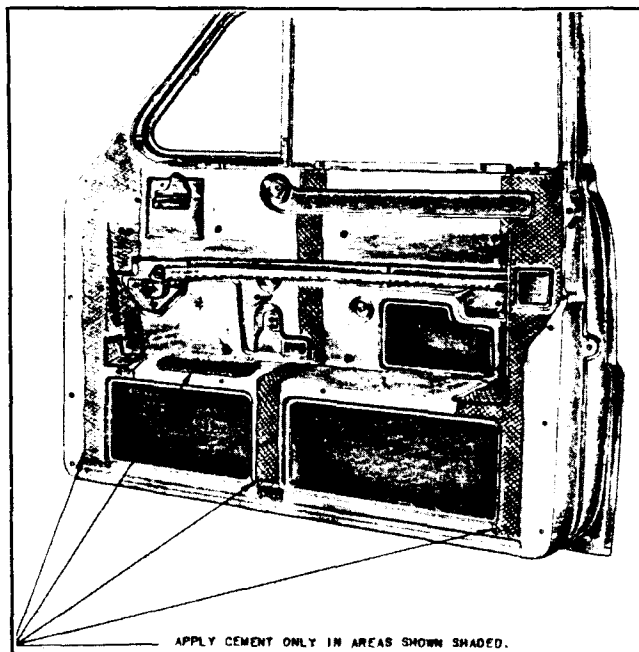
Cemented inside the external metal panel of each door is a large pad of soft waffled cardboard, similar to the material cemented to car floors and

inside roof. This material is used as a silencer, and is especially important in bodies of unitized or "Monobilt" construction. Mounted inside door shell, it helps ensure that car door closes with a proper solid dull "thunk" rather than a metallic "wham" or a loud resonant "boommm." If door silencer pad has shifted or loosened, it should be cemented back in place (it can be cut and remounted in pieces if necessary). To minimize rust problems, it probably need not cover the bottom 6 inches or so of door metal — but should be firmly attached to the surface above that, to damp out vibration. The best automotive trim cement is not needed here; ordinary undercoating mastic compound, or even asphalt roof cement, will serve about as well, and will add somewhat to the silencing effect.
