Hudsonotes

Column of Mechanical Miscellany
by George Schmidt
Mishicot, Wisc.

No Hunting

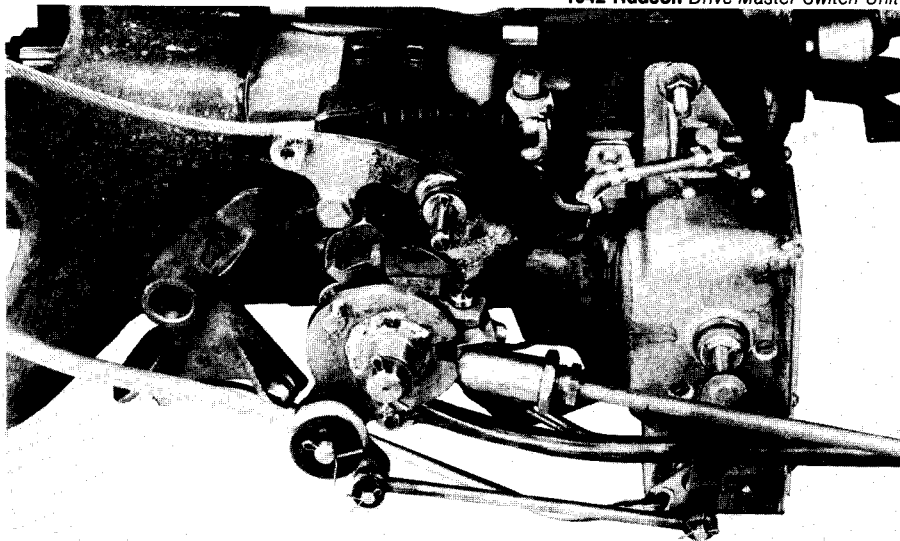
1942 Hudson Drive-Master Switch Unit.

One periodic example of the latter, particularly on Drive-Master, seems to be the "neutral switch" arrangement which is designed to stop a shift from either direction at half-stroke, in the center, whenever neutral is selected at hand lever. Contacts here are usually OK, but unless there is plenty of friction at vacuum piston, linkage, neutral switch, etc., this shift tends to overshoot the center point, thus actuating the opposite shift valve and moving back; then the first one again; and so on as linkage oscillates busily around the center position — about like a pneumatic hammer, or a milking-machine pulsator gone wild.

Several other corrections for the hunting problem, such as tighter friction packing at neutral-switch shaft, and looser connection at switch linkage, have been suggested in a past WTN article (see "Making Drivemaster Work," Feb. 1975); but sometimes even these are not enough. The twin neutral-switch contacts (inside transmission-switch box, operated by large black cam and the slotted lever at side) are spaced quite close together, and unfortunately are not adjustable. They are held apart only by the thickness of the cam (about $\frac{1}{4}$ "), and this may not be sufficient to damp out the motion, especially if cam tip shows wear. The remedy, which I've used successfully in stubborn cases, is to thicken end of cam by building it up with any smooth flexible insulating material, epoxied carefully in place. I used a piece of leather, $\frac{3}{4}$ " x 2", and about .05" thick; but cloth or plastic should serve as well. Spacing of the "limit switch" contacts will also be affected, but this is not as critical, and can be adjusted to compensate (note setscrew at each side).

Reassemble switch box, install it on car, and adjust the neutral-switch link if necessary. Centering of shifts into neutral may be slightly less exact, but this should cause no problem when driving, if link is set correctly. Grease transfer key and oil joints in linkage.
