Hudsonotes

Column of Mechanical Miscellany
by George Schmidt
Mishicot, Wisc.

UPHOLSTERY

AND TRIM REPAIRS

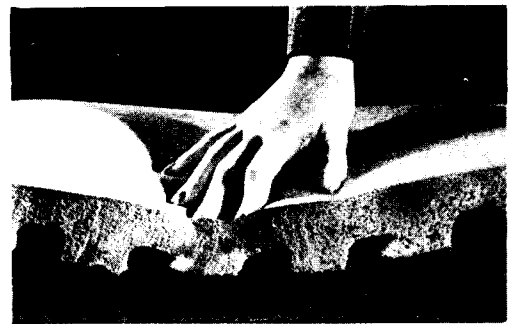
Improved Airfoam Seat Cushions...firm, but unbelievably soft and cool, because this amazing material "breathes" through countless interconnecting air cells as your body moves up and down.

HUDSON IN 1939 (in cooperation with Goodyear) pioneered the use of foam rubber in automotive seat cushions, and this feature was continued thereafter as an option (also standard on front seats of some models). Each cushion so constructed had an identifying tag sewn into one seam.

However, unlike most Brand X builders today, Hudson did not attempt to use rubber or other foam as a substitute for properly constructed seat springs. Deep full-coil springs were still used on all models, and the "Airfoam" pads were installed over these, replacing part of the usual cotton stuffing. The resulting seats were neither cheap nor especially compact, but they were - and are - unequalled for comfort, as can still be noted particularly when taking a long trip in one of these cars, and then changing over to a present-day Brand X vehicle. On stepdowns, a production change from first to second type spring units for front seatbacks c. mid - '49 (note part-number tag on coils) had little effect on comfort or interchangeability, except that right and left units on a 2-door model should match, and first-type springs were perhaps a trifle softer. Both types were used either with or without foam rubber.

Foam pads for seatbacks were quite soft, and those for lower or bench cushions were firmer. Most have proved quite durable over the years,
